# *Gilding Conservation at the Washington Monument*

## **Overview:**

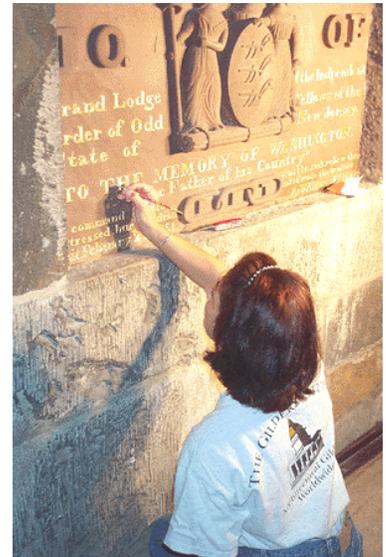
*Lisa DaSilva working on the gilding of a Brownstone tablet from the Grand Lodge of OddFellows of New Jersey.*

The stones were inspected and cleaned to remove staining and efflorescence as well as mineral salts produced by the wet conditions. The existing gold was examined microscopically to best match the original color and alloy. Loose and flaking layers of gold and primers were then removed. The remaining well adhered original layers of gold leaf and primers were isolated with a coat of Soluvar Matte varnish.

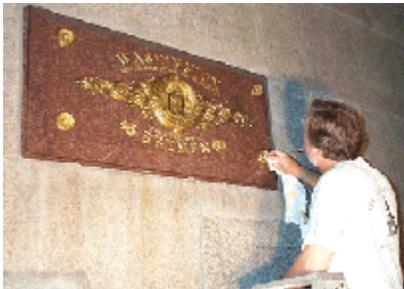
*Michael Kramer toning the gilded medallions on the Bremen stone.*

of original gilding. The stones were gilded with different alloys of 23 and 23.5 karat leaf to most closely match the original colors. Toning was done on selected areas as needed.

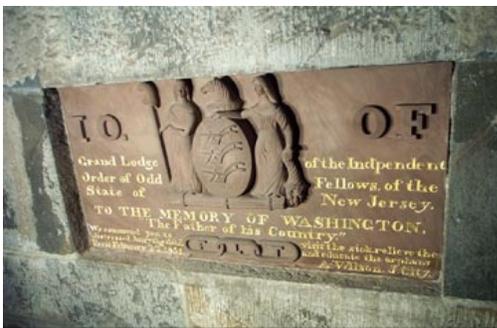
*The Completed Gilding on the OddFellows Stone.*

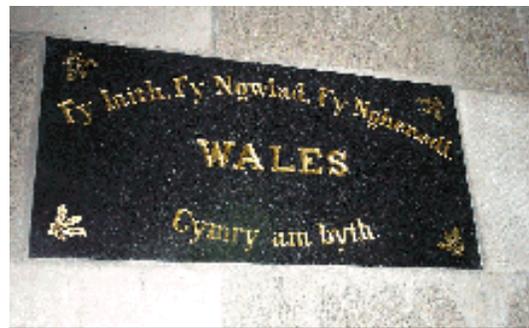
*Completed Gilding on City of Wales' Granite Stone.*
